Aberdeen Creek HOA Irrigation System Check

Date: 09/23/2020

Checked By: Cliff Reiss

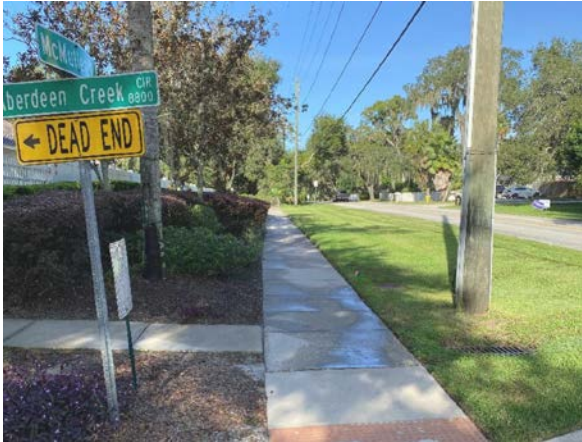
- **Zone 1 (Center Island)** – OK – no broken spray head or rotors
- **Zone 2 (West Beds)** – OK – no broken spray head or rotors
- **Zone 3 (East Grass)** – OK – no broken spray head or rotors
- **Zone 4 (West Grass)** – FIX– one broken rotor or line – Excelsior work order sent @9:30am
- **Zone 5 (East Beds/Front Island)** – OK – no broken spray head or rotors

- Remove grass around heads – common area Zone 1 and sidewalk rotors
- Place rings around rotors in common area and sidewalk grass areas if needed
- Check for clogged spray heads and clean / replace
- Adjust coverage pattern on Rotors and spray heads
- Rewire PRO-C Controller for direct connection (instead of plug); install GFI outlet
